**RECONSTRUCTING THE ASSEMBLAGE OF IRON ARTIFACTS FROM THE  
LATE HELLENISTIC SHIPWRECK AT KIZILBURUN, TURKEY**

A Thesis

Submitted to the Office of Graduate Studies of  
Texas A&M University  
in partial fulfillment of the requirements for the degree of

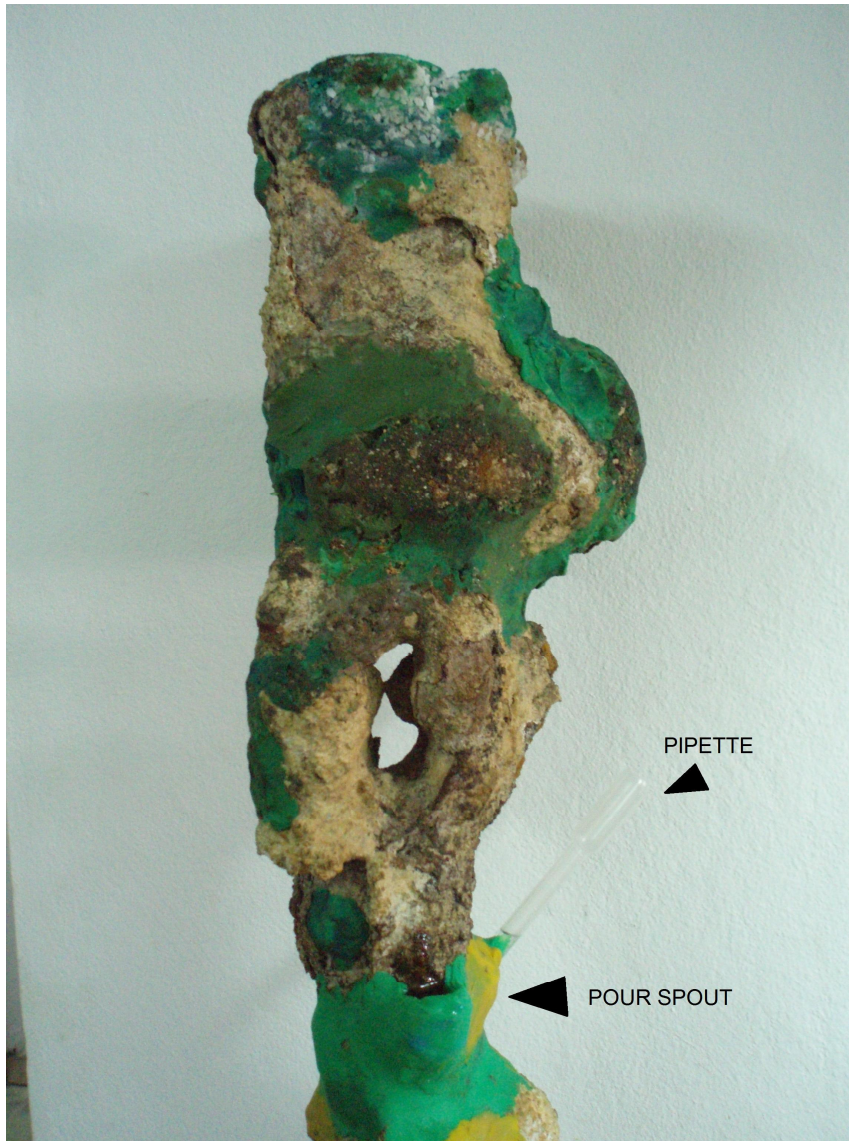
Fig. 2.19: Detail of ABX-1 with plastic pipette and pour spout.

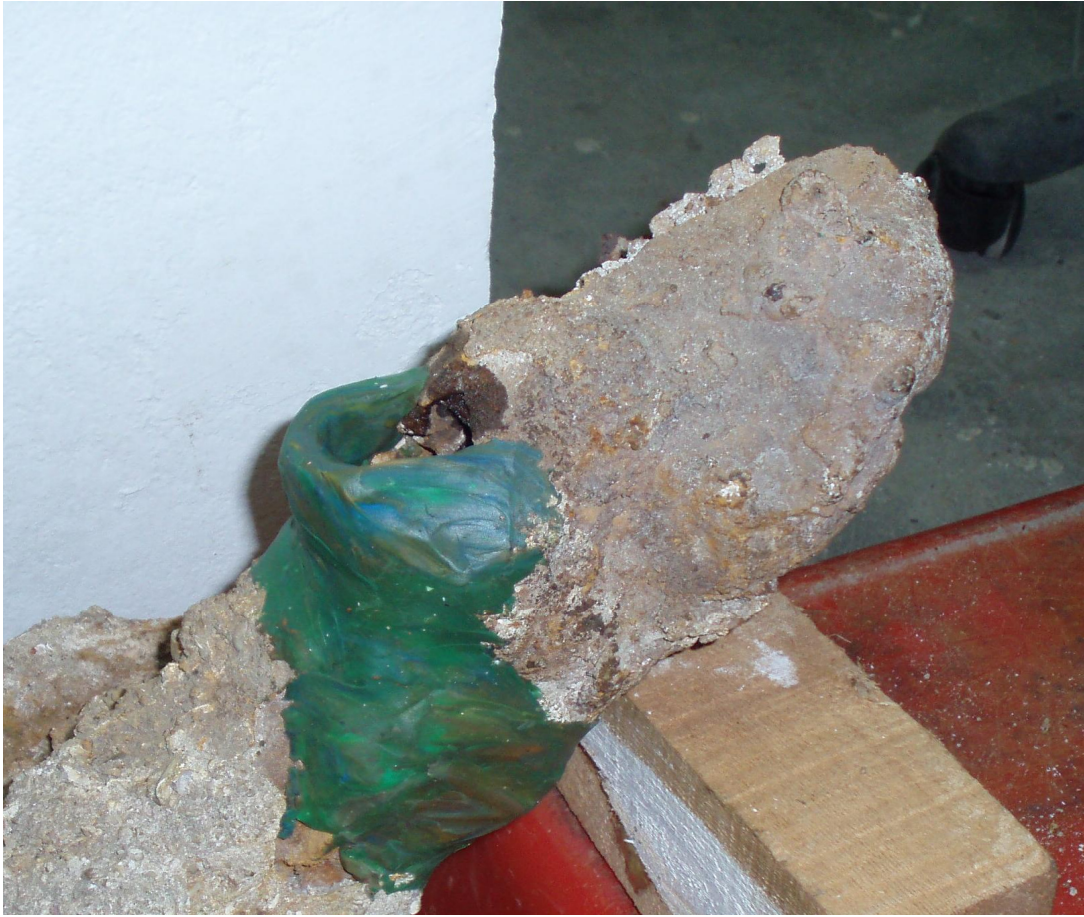
Fig. 2.20: The pour spout designed for ABX-3.

The last part to be cast was the tooth portion of ABX-3. Consolidation of the iron surfaces of the delicate tooth was attempted by injecting epoxy into the sand. By doing this, the iron remained in place, held steady by the encompassing cushion of now solidified sand. After pouring epoxy into the tooth, the rest of the ABX-3 arm was filled as much as possible. One hole was drilled into the tooth section, as described above for ABX-1, to allow for complete filling of the cavity. Only one hole was needed, since ABX-3 naturally lies on its side, unlike ABX-1 which was required to stand upright. Air bubbles within the cast did not prove to be an issue. The tooth was reattached with a bridge of plasticine, and a spout was formed to enable pouring of epoxy into the void (Fig. 2.20). The anchor, now in one piece, was allowed to sit for 24 hours before air scribing commenced (Fig. 2.21).

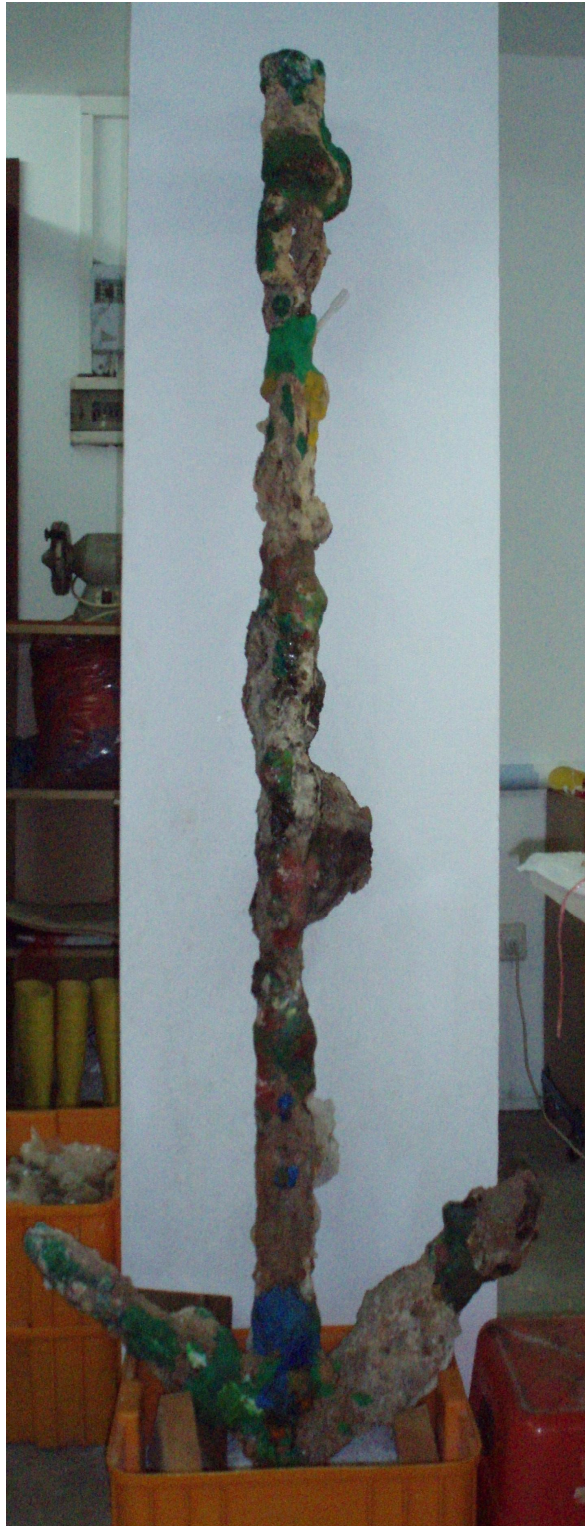
Fig. 2.21: The fully reconstructed and cast iron anchor concretion.

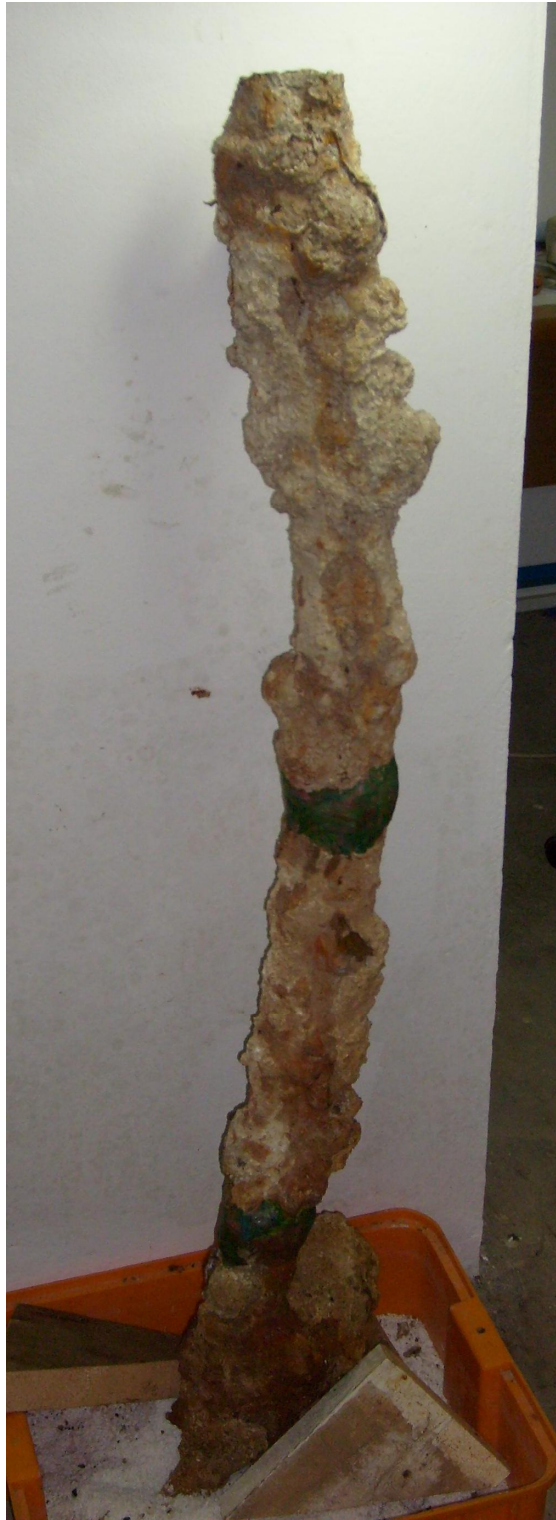
Fig. 2.22: The fully reconstructed and cast iron anchor stock concretion.

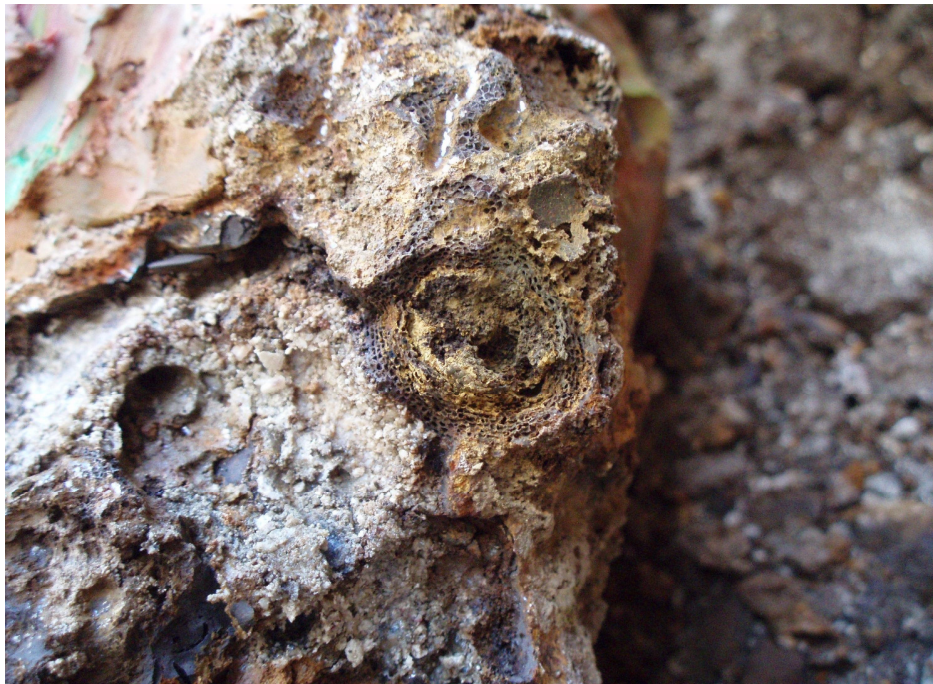
Fig. 2.23: Preserved cross-section of possible rope within the anchor concretion.

diameters of 4.0 cm and 1.6 cm for the upper and lower ropes respectively.<sup>34</sup> Taking these measurements into consideration, it may be that the rope found within the Kızılburun anchor concretion was meant for the trip-line, the line attached to the crown of the anchor to enable easier removal from the seabed. However, without any additional rope remains, and given its central location along the anchor's shank, it is impossible to say definitively which line it represents.

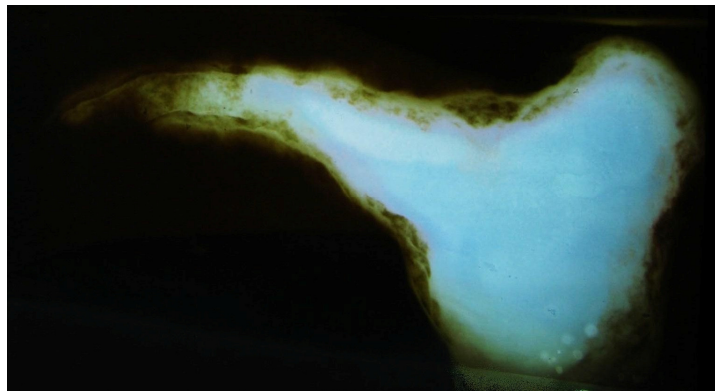
Fig. 2.24: X-ray of the anchor's ring (Lot 311), taken with the x-ray machine in the Nixon Griffis Laboratory.

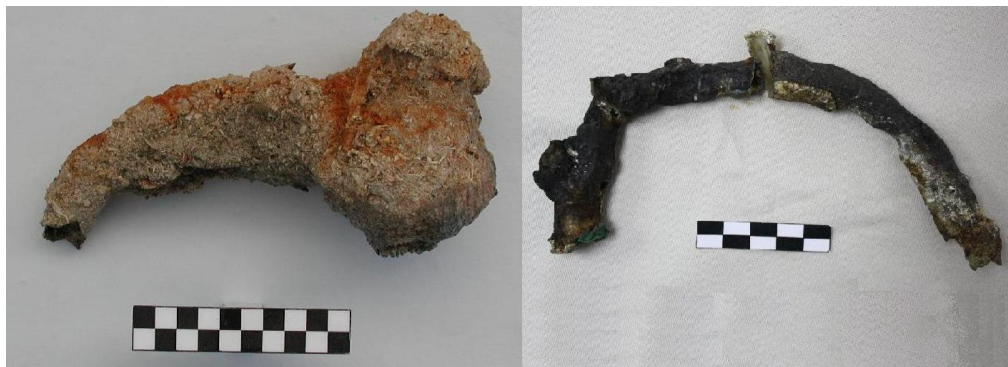
Fig. 2.25: **AR 1**, the anchor's ring after excavation and following casting.

All that was preserved of the elements for securing cables to the anchor was a portion of a ring (**AR 1**) that would have been attached at the head of the shank. Although there was an aperture at the crown as well, the crown ring did not survive. Following casting, the bulbous object found lying downslope of the anchor concretion (Lot 311) was revealed to be a fragment of the upper ring. In its x-ray (Fig. 2.24), the outline of the ring is seen, as well as its curvature. Despite not surviving in its entirety, the diameter can be estimated at 14.0 cm and the thickness at 1.0 cm, although it is impossible to remark on its manufacture. The ring survived in two cast sections, but the second of the two is in such a poor state that no relevant measurements could be deduced (Fig. 2.25).

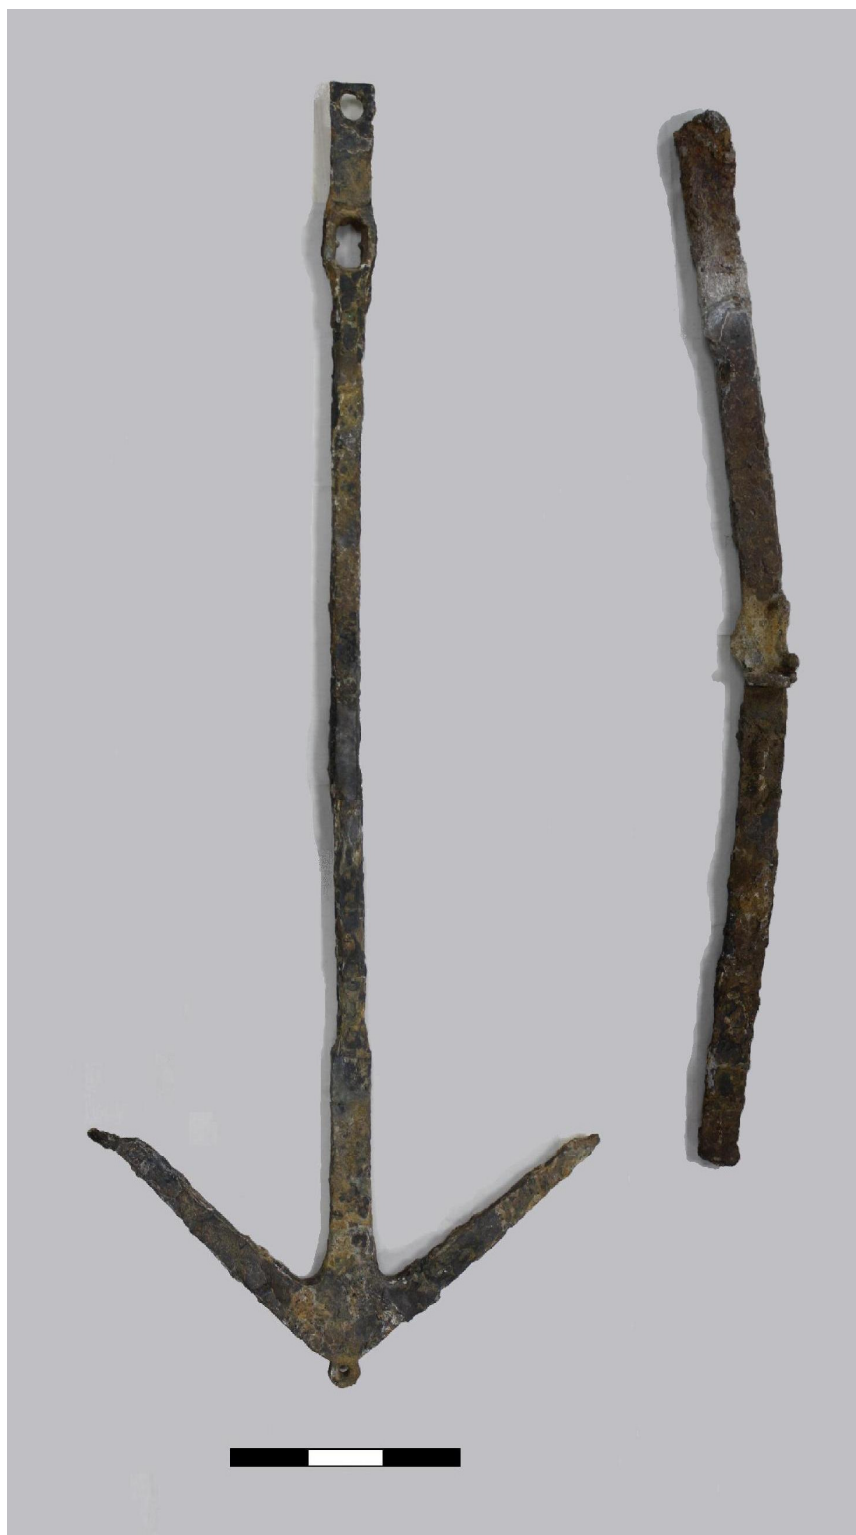
Fig. 2.26: AN 1 (left) and ST 1 (right).

The Kızılburun iron anchor is an unusual find in that both the anchor and its stock were found intact (Fig. 2.26). The anchor is 1.64 m long with an arm span of 69.2 cm. A rough estimate of its original weight including the stock is 38.5 kg, calculated using the density of iron and the volumetric measure of the anchor in cubic centimeters.

There are several details that can be deduced from the anchor's position on the seabed. The fact that it was lying on its own stock denotes that the anchor was stowed and not actually in use at the time of the ship's sinking. The orientation of the nails found beneath the stock reveals that it was likely stowed in the hold of the ship and was lying against part of the wooden structure. The presence of clenched nail tips within the anchor's concretion indicates that the anchor was resting directly against a frame within the hold. During construction of a wooden hull, nails are driven through planking and clenched over a framing timber; the clenched tips abutting the stock in this case eliminate any space necessary for a layer of internal planks. Had the nail heads and not the tips been concreted to the underside of the anchor, this might have suggested a location on deck, or the presence of ceiling planking within the hold. The iron anchor from the Grand Rouveau shipwreck in France also contained traces of wooden planking and mortises within its concretion, suggesting that it too was not the primary anchor and was stowed at the time of sinking<sup>39</sup>

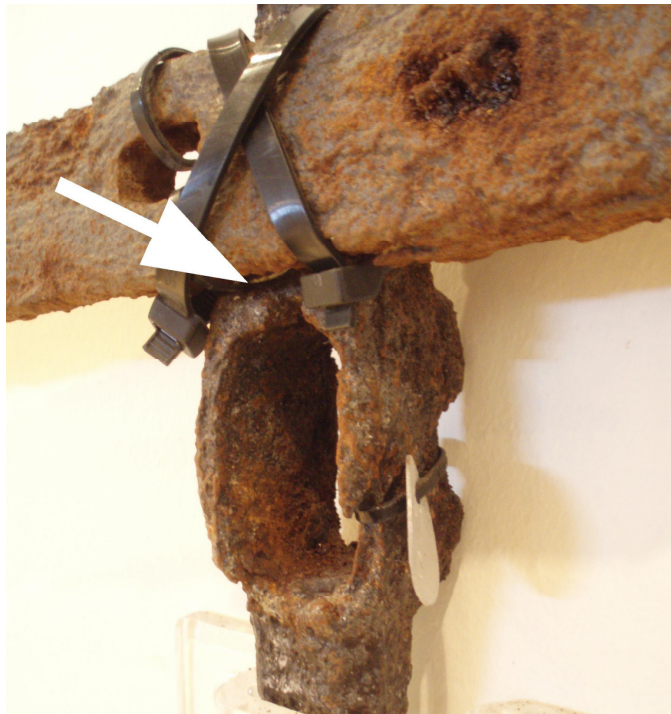
Fig. 2.27: Close up of Haifa anchor with notch in top of stock aperture (photo by author).

The stock aperture revealed an interesting feature during manual cleaning, and after inspecting the smaller of the two iron anchors from Ashkelon, now in the Haifa Museum, it seems that this trait may have been common of ancient iron anchors. On both the small two-armed anchor from Ashkelon (Fig. 2.27) and the Kızılburun anchor

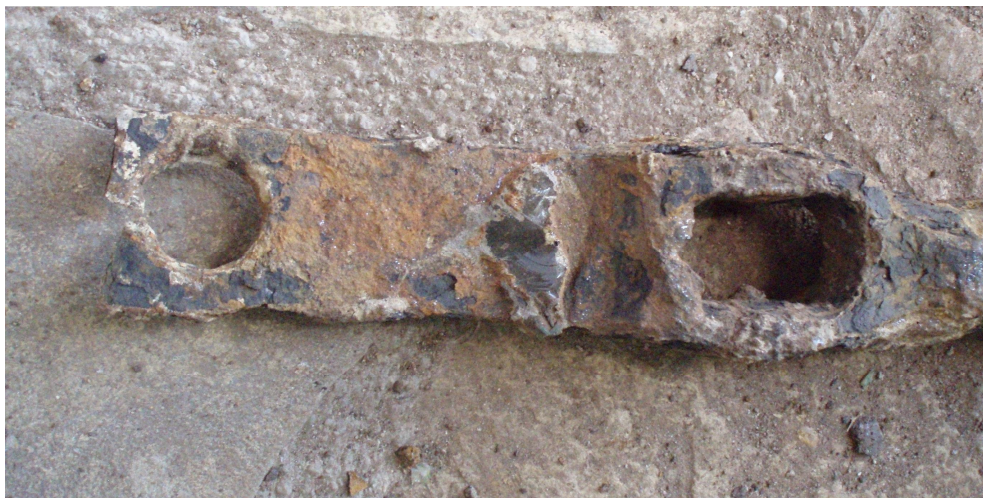
Fig. 2.28: Close up of AN 1 showing notch.

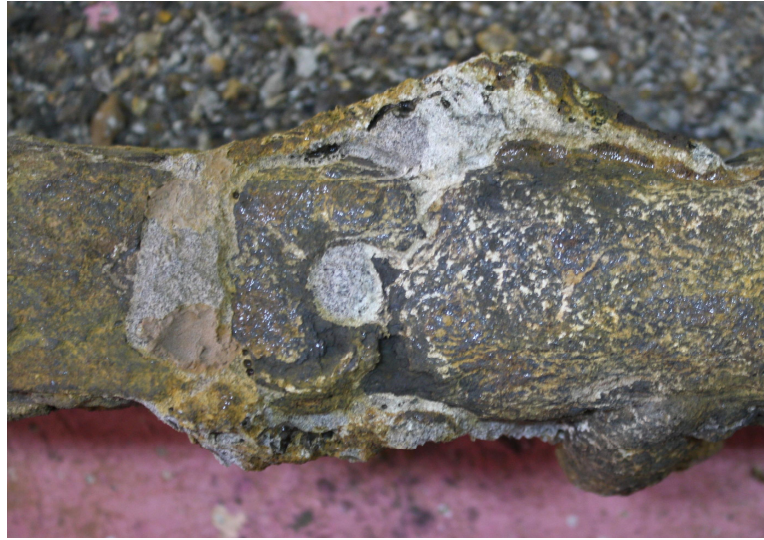
Fig. 2.29: Evidence of pin-hole in stock in the form of round epoxy leak.

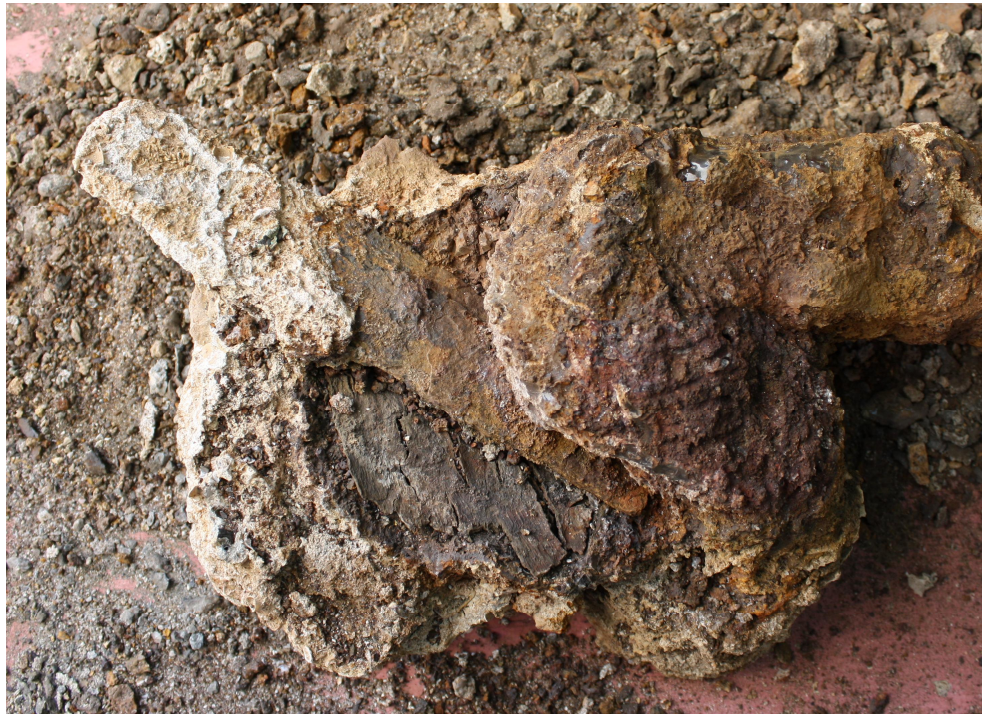
Fig. 2.30: Detail of iron bar and wood remains concreted to ABX-8.

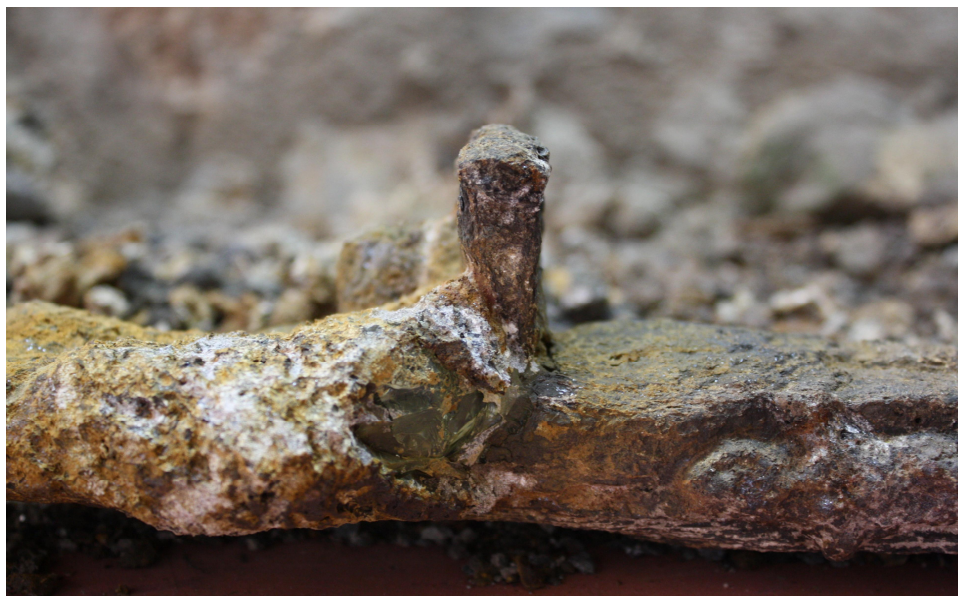
Fig. 2.31: Detail of step.

During removal of the concretion from the stock in 2009, it became apparent that the step designed to hold the stock in place had survived. The lines of the step are visible in the x-ray, but since only one angle was shot, the extent of its preservation was uncertain, although eventually it was found to be well-preserved (Fig. 2.31). In situ, the stock was situated with the step facing downward. There is also a noticeable twist to the stock: it is not simply straight and flat, but after moving past the step, one end is twisted, which may have been either a result of manufacture or a violent shock during previous use.

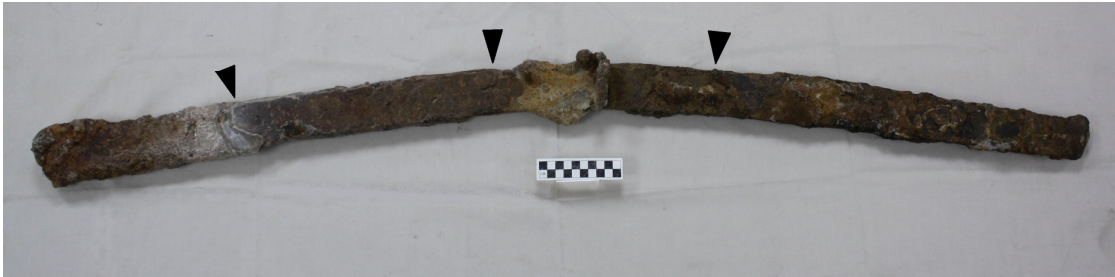
Fig. 2.32: Position of welds visible on underside of anchor stock.

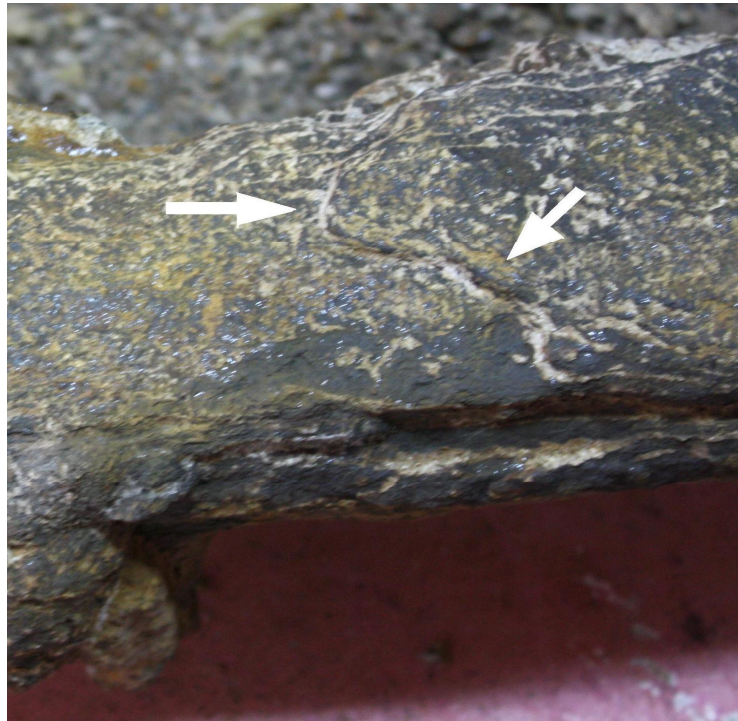
Fig. 2.33: Detail of weld nearest step.

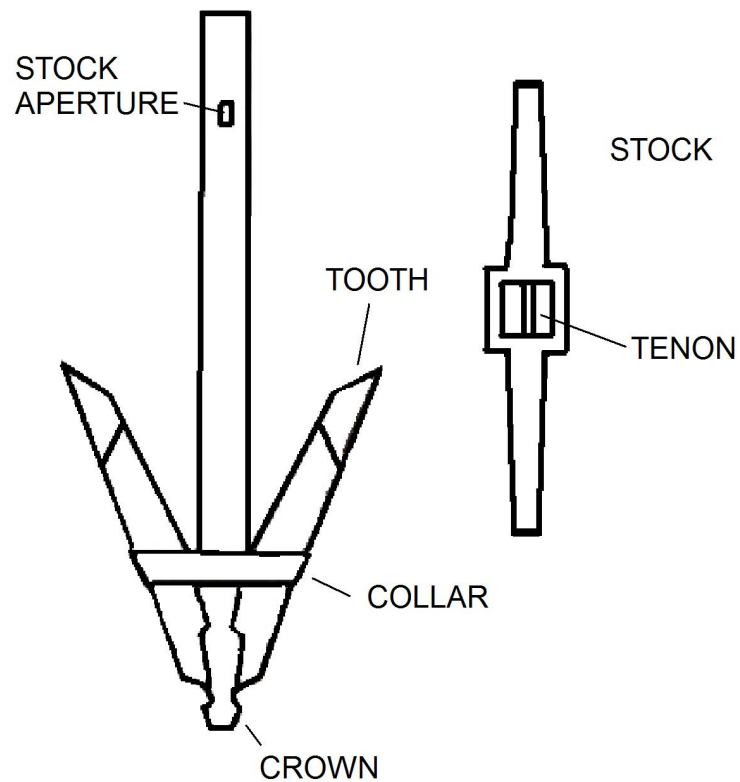
Fig. 2.34: Components of an ancient wooden anchor (left) and its stock (right) (drawing by author).

sheathed in bronze or iron teeth (Fig. 2.34).<sup>54</sup>

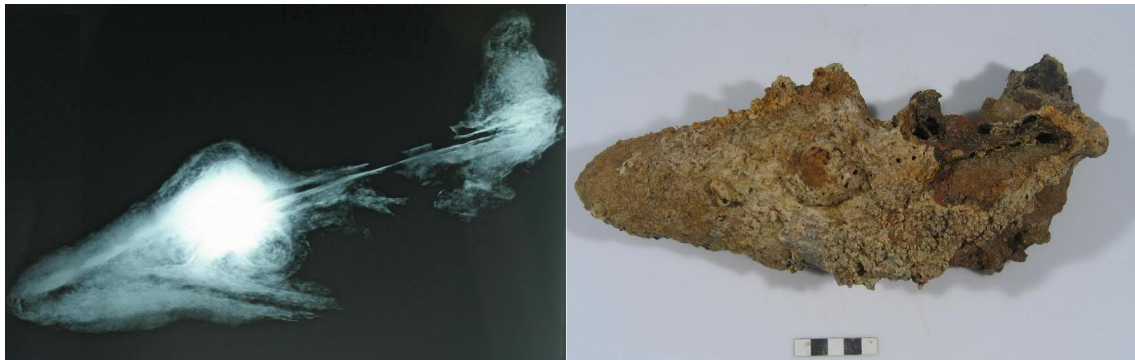
Fig. 2.35: X-ray of **AT 1** (left) and its concretion (right).

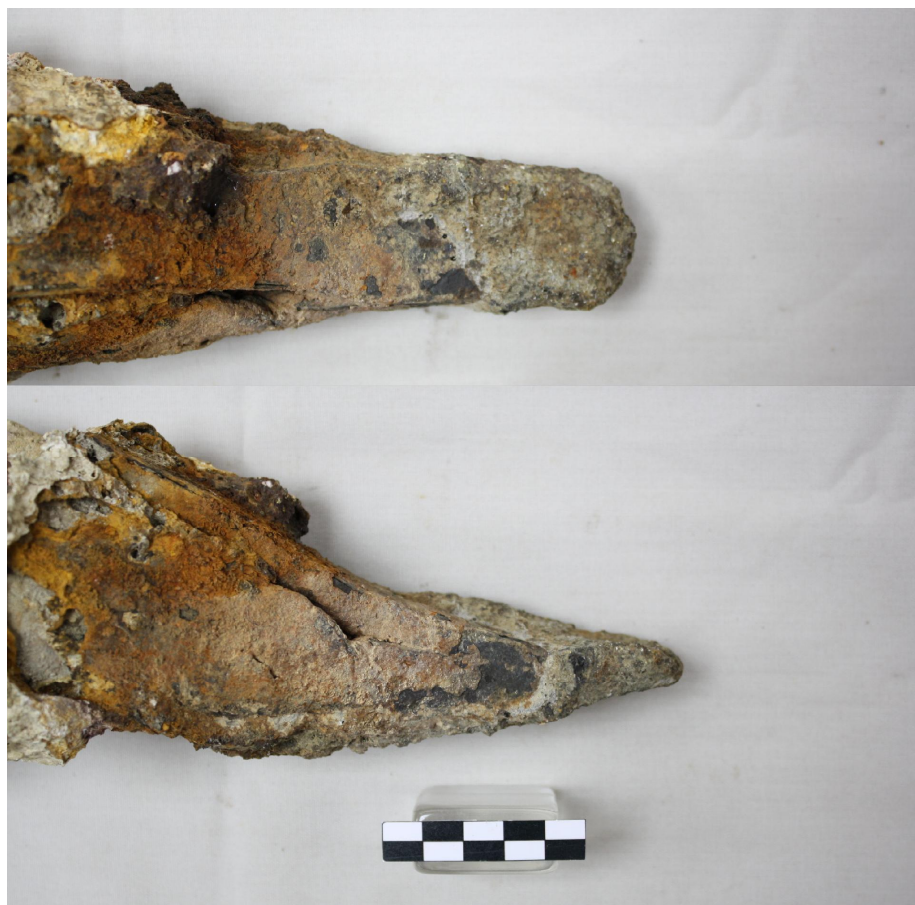
Fig. 2.36: Two views of **AT 1** following removal of majority of encrustation.

Casting the object was challenging, as the thinnest areas of the concretion housed what can best be described as a sheet of iron, therefore the cavity surviving in this case was very thin. The broken extremity was cast first and then reattached to the upper portion of the concretion using plasticine. The fragments of the thinner concretion, created while separating the bottom, were pieced back together and held in place with plasticine

bridges. Epoxy was drizzled down the iron sheet until it seemed that the larger cavities had been filled. The encrustation surrounding the end of the tooth was removed easily and revealed a well-preserved epoxy replica of the once iron object (Fig. 2.36).

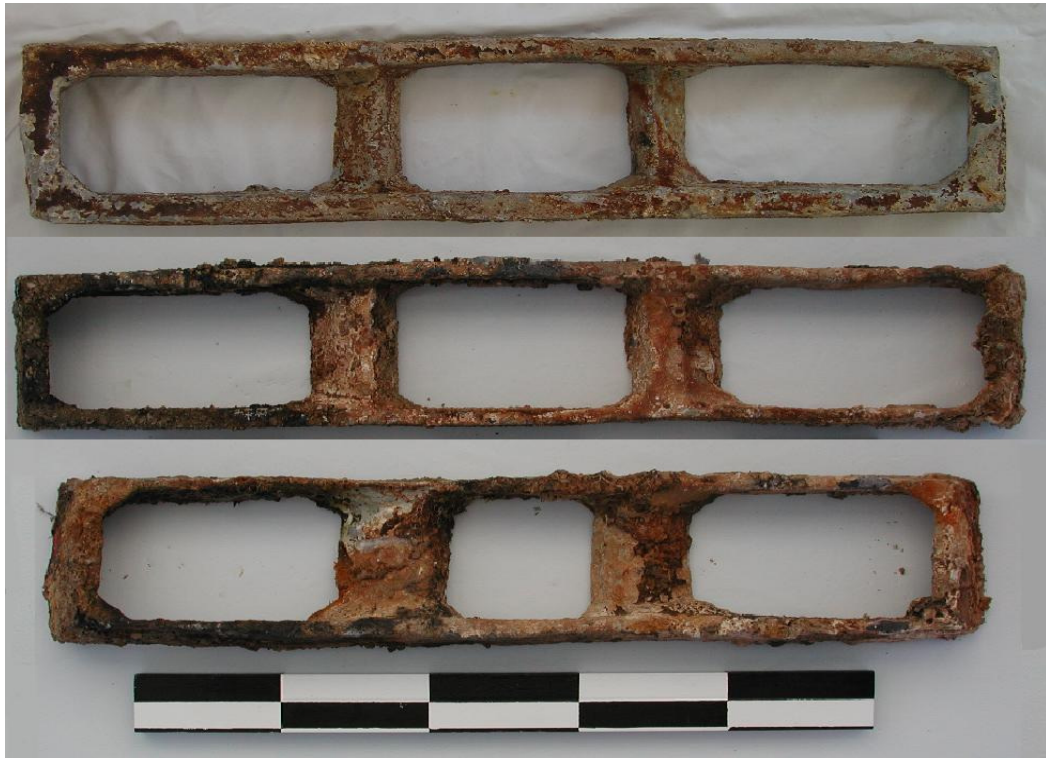
Fig. 2.37: 3 lead anchor collars (Lots 887, 369 and 368 from top to bottom) found on the wreck site (photos by H. Brown and J. Levin).

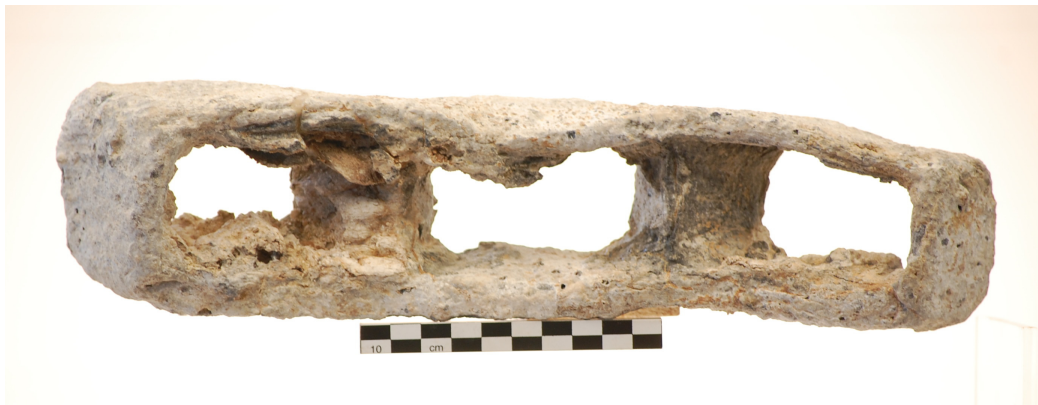
Fig. 2.38: Lot 1220, the anchor collar found beneath Drum 1 (photo by J. Littlefield).

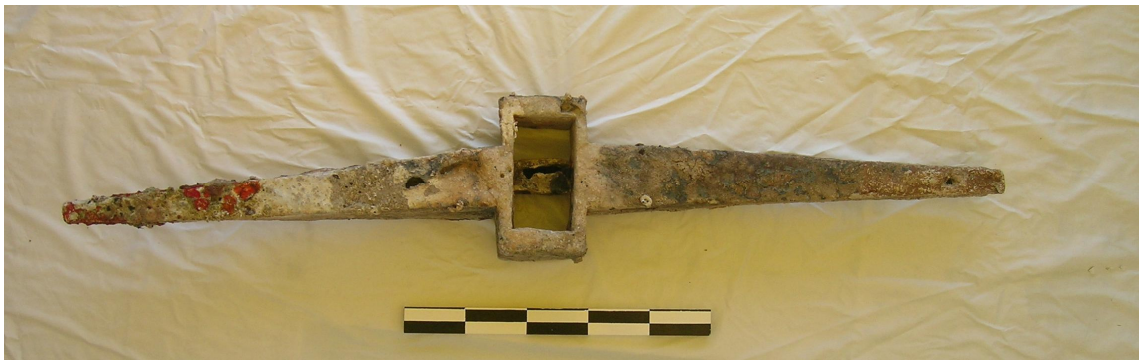
Fig. 2.39: Lot 825, the larger of the two lead anchor stocks (photo by H. Brown).

The two lead anchor stocks are of different types. The first stock (Lot 825), weighing 105.72 kg, was found near two lead anchor collars in area 18, and it is a type commonly found in the Western Mediterranean (Fig. 2.39).<sup>69</sup> The heavy stock enabled the teeth of the anchor to better grip the sea floor. This lead stock is a permanently fixed type, in that once it was affixed to the anchor, the stock could not be removed without damaging the anchor itself, since it has a central lead tenon which pierced the wooden anchor shank. Haldane refers to this type as a Type III-B stationary lead stock, the use of which occurred between the 3<sup>rd</sup> century B.C.E. and the 1<sup>st</sup> century C.E.<sup>70</sup>

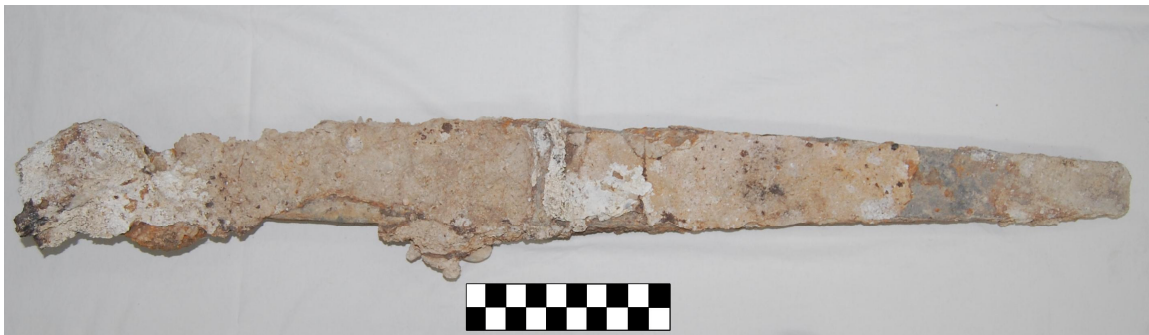
Fig. 2.40: Lot 1334, the heavily concreted removable lead stock (photo by J. Littlefield).

The second stock (Lot 1334), weighing 34.32 kg, exemplifies a transitional design and an improvement in anchor technology (Fig. 2.40). It was located upslope and approximately 20 m northeast of the main wreck site, but this fact does not negate its inclusion in the Kızılburun assemblage. Haldane characterizes stocks of this design as a

Type IV-B removable lead stock with step, which laid the groundwork for the technological transition to iron anchors with removable stocks. He also characterizes this type as being predominately Eastern Mediterranean.<sup>71</sup> Whereas the stationary stock was permanently affixed to the wooden anchor during manufacture, a removable stock was produced separately and attached only when in use by being slotted through a rectangular cutout in the anchor's shank and being held in place with a pin. An anchor of this design was advantageous in being more easily stowed and in essence collapsible as it can be stored flat on the deck. It also has its limitations, because inserting the stock before use requires more handling and this in effect would limit the overall weight of the anchor.<sup>72</sup> This could account for the great difference in the weights of the two recovered stocks.

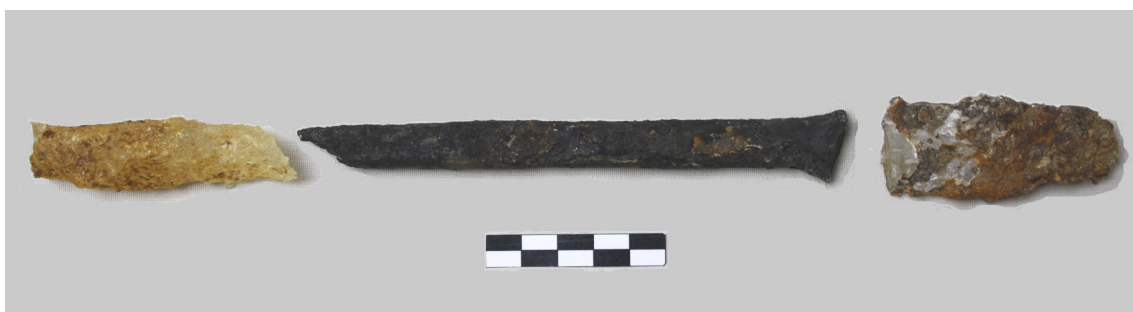
Fig. 3.1: The three components (handle, shaft and blade from left to right) of **CH 1**.

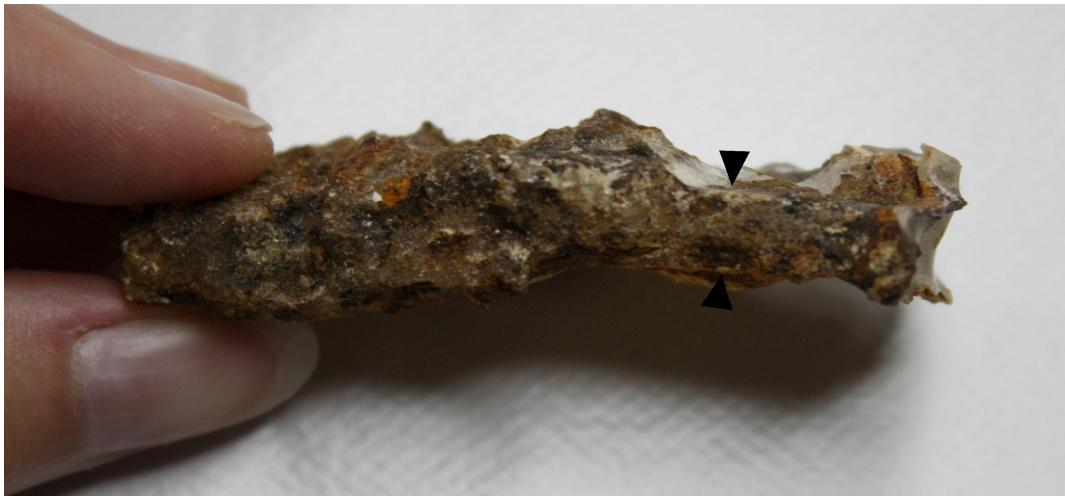
Fig. 3.2: Arrows marking where defined edges reflect the original thickness of the blade.

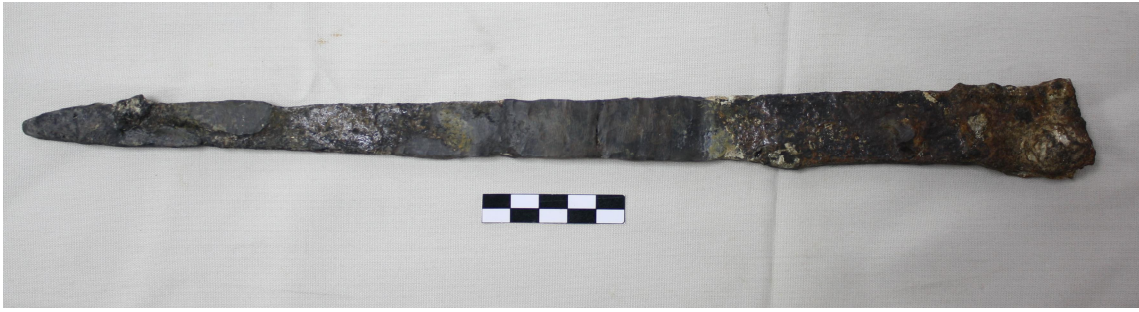
Fig. 3.3: **CH 2** after casting.

It was theorized at first that it might be a bladed instrument, like a knife, but there are no sharp edges to indicate that it served this purpose: its cross-section would be triangular to reflect at least one sharpened edge. **CH 2** maintains its rectangular cross-section throughout as it tapers. No other concretions were found which might be portions of the same object. It was thought as well that the iron rod may represent a portion of a file, like one found in London measuring 20.3 cm in length,<sup>107</sup> but the surface lacks the characteristic striations, which should have been preserved in the epoxy replica (Fig. 3.3).

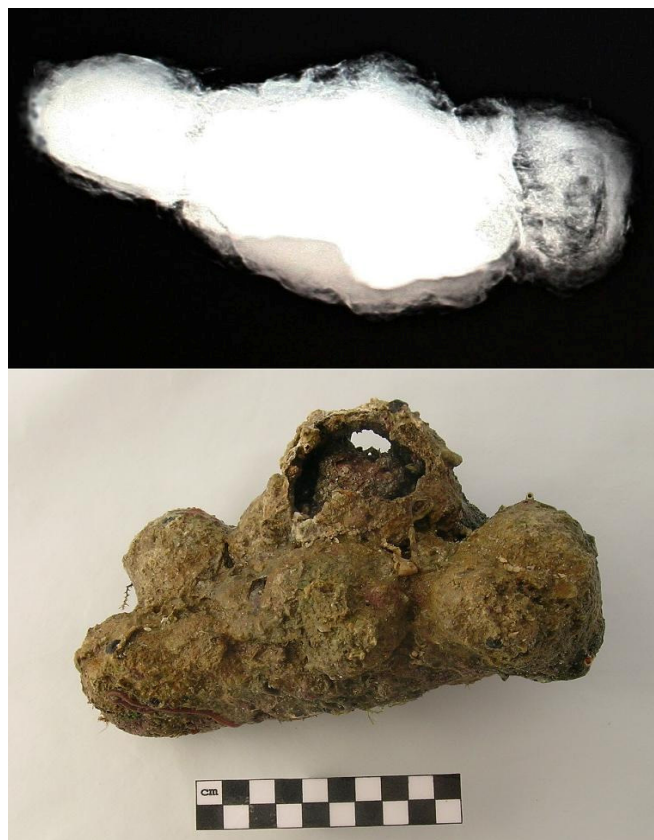
Fig. 3.4: X-ray of nail remover (top) with majority of object obscured by dense concretion except uppermost portion of handle, and as it appeared before manual cleaning (bottom).

Initially, casting **NR 1** (Lot 741) seemed a relatively simple task; however, it became obvious that any object within could not be identified easily using the x-ray alone (Fig. 3.4). It was decided that the best option was to break open the small dense concretion, as opposed to cutting it with a saw. A break fits together cleanly when reconnecting the fragments, whereas sawing leaves a small gap. However, instead of breaking cleanly apart, a hole was punched into the cavity, which prevented a thorough study of the shape of the void. Through this hole, it was possible to clean out what seemed to be the extent of the cavity, and epoxy was poured inside and allowed to harden. During mechanical cleaning, the handle portion was revealed first followed by the two claws, and it was assumed at the time that the tool was a claw hammer. Additional research suggests that it is not a hammer at all, but a nail remover. The handle ends in a blunt surface, which itself can be hammered, providing extra force when trying to free a particularly stubborn nail.<sup>112</sup>

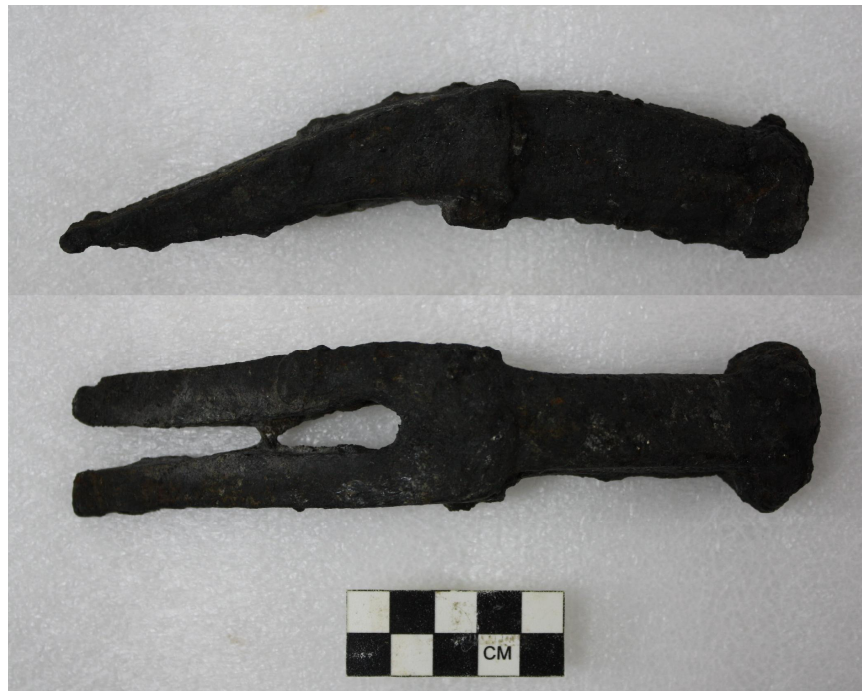
Fig. 3.5: Two views of **NR 1**, after casting.

a once iron tool, and following filling with silicone and removal of the surrounding encrustation, the authors were able to identify the object as a tool whose purpose was to remove nails from wood.<sup>114</sup> Similar in form, the two examples do have differences in their details. The nail remover from Cala Culip IV is slightly longer, measuring an approximate 22.0 cm, while the Kızılburun example measures 17.3 cm, and the example from Cala Culip IV appears more angular compared to the delicate curvature of that from Kızılburun (Fig. 3.5).

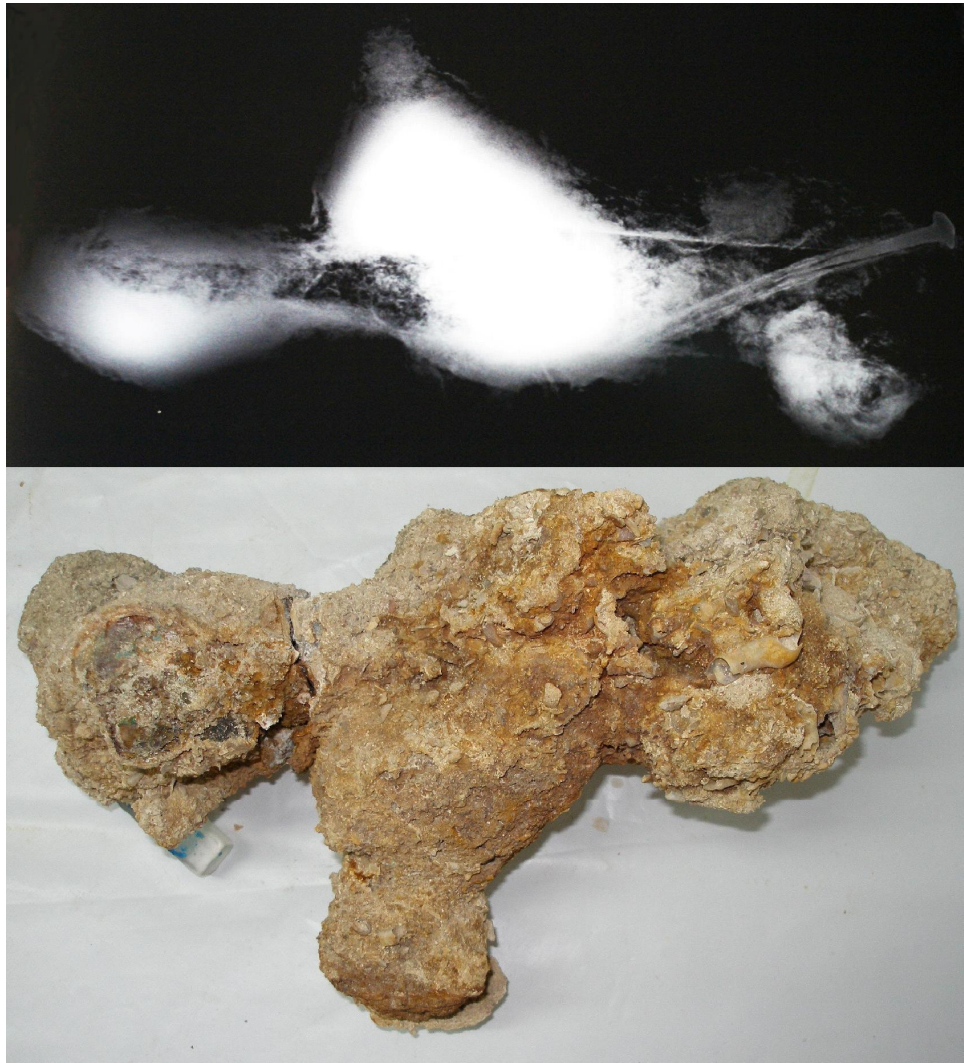
Fig. 3.6: X-ray of **AA 1** (top) showing nail concreted to adze blade, and as it appeared before mechanical cleaning (bottom).

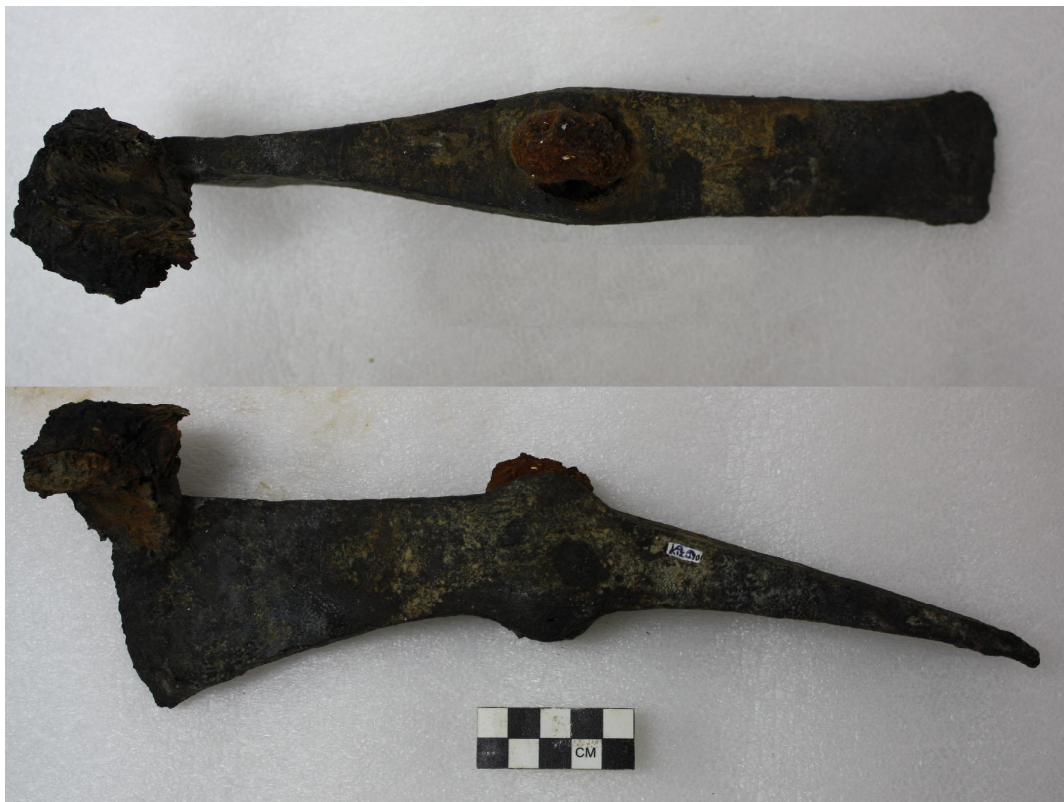
Fig. 3.7: **AA 1** after cleaning, with wood fragment concreted to axe blade (bottom), and portion of wooden handle preserved due to iron corrosion (top).

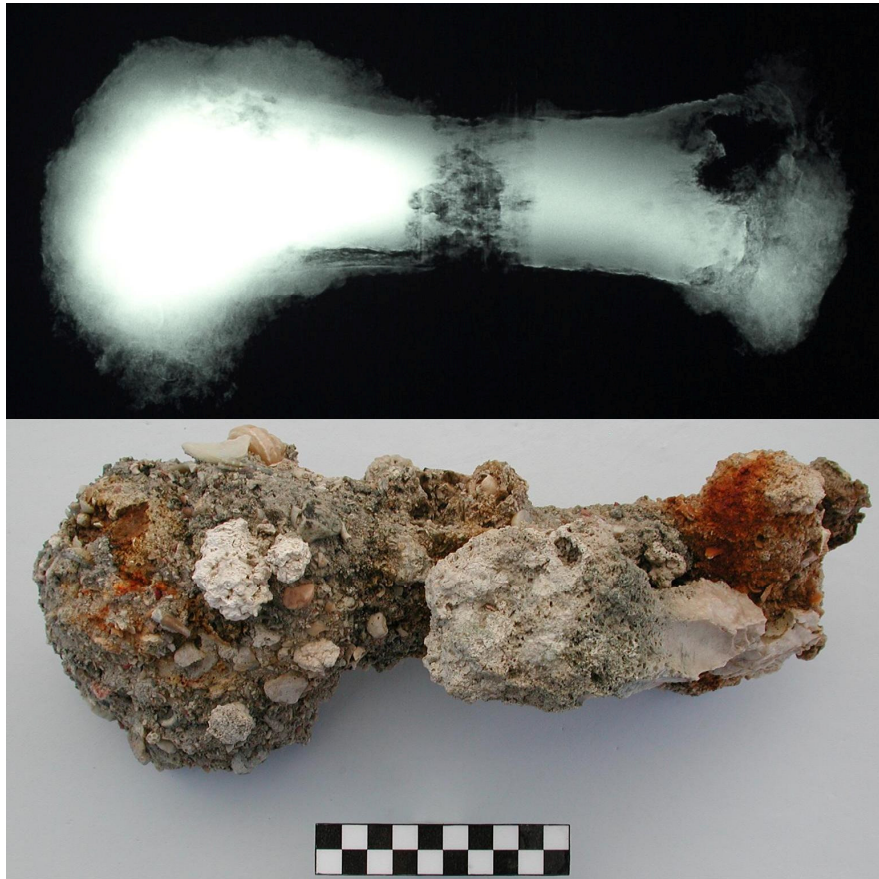
Fig. 3.10: X-ray of **AX 1** (top) with iron indicated by the white portions of the image, and as it appeared before conservation (bottom) (after Rash 2010 Fig. 2; used with permission from CMAC).

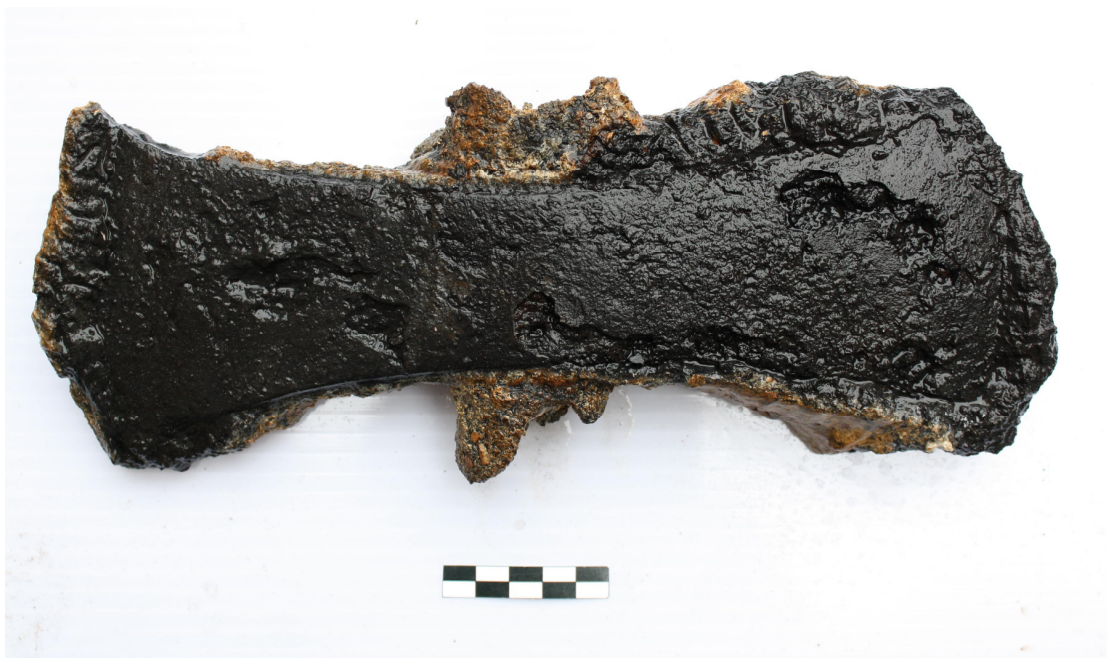
Fig. 3.11: **AX 1** following the removal of concretion from one surface.

In February 2011, after 12 months of titrations revealed very little change in the chloride content, the concretion was removed from one face of the axe, exposing the iron (Fig. 3.11). It is probable that the heavy concretion covering the iron prevented removal of
